Figure 1: Pointcloud received from client, including internal and external data.

Figure 2: Ground and First Floor Plans of fire damaged units, including attached outbuildings.

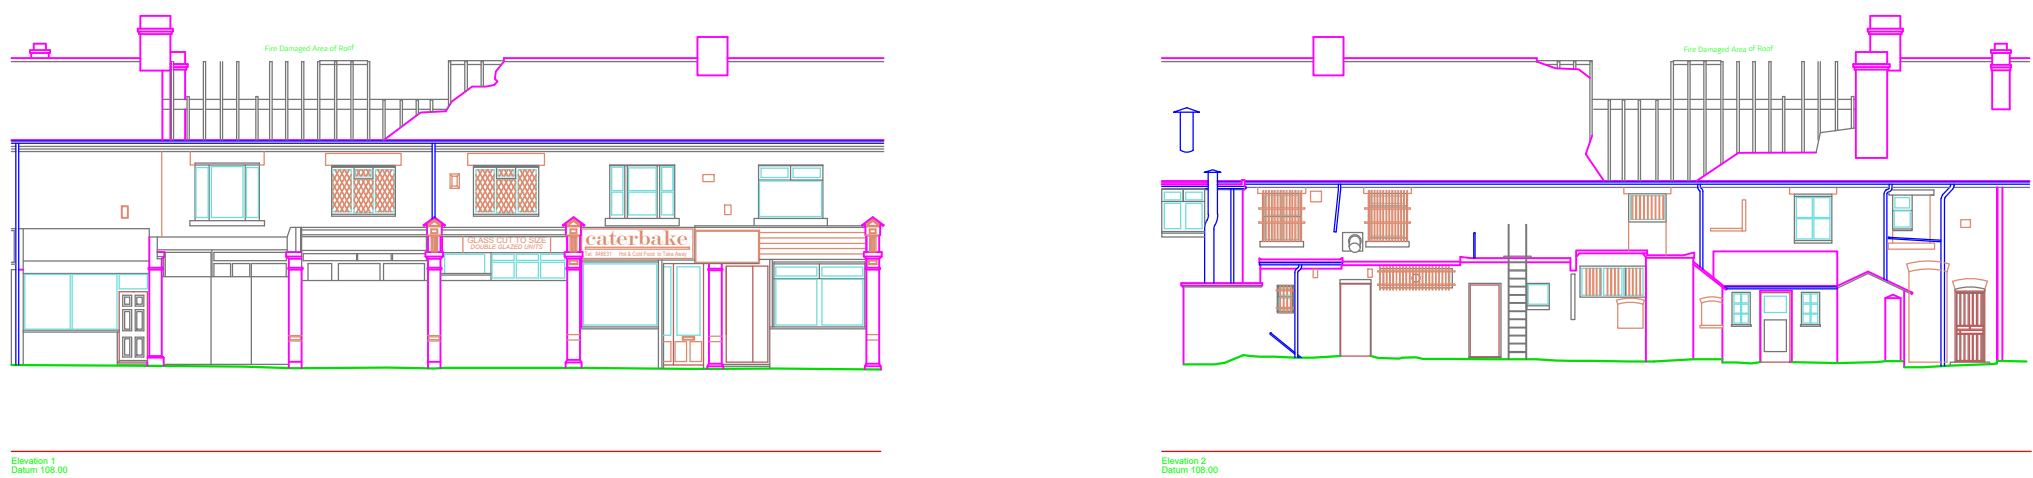
Figure 3: Front and rear elevations of retail units, showing extent of damage to roof and roof structure.
